1 **Surface rupture of the Hundalee Fault during the M_w7.8 2016 Kaikōura Earthquake**

2 Jack N Williams*, David J A Barrell, Mark W Stirling, Katrina M Sauer, Grace C Duke, Ken X Hao

Abstract

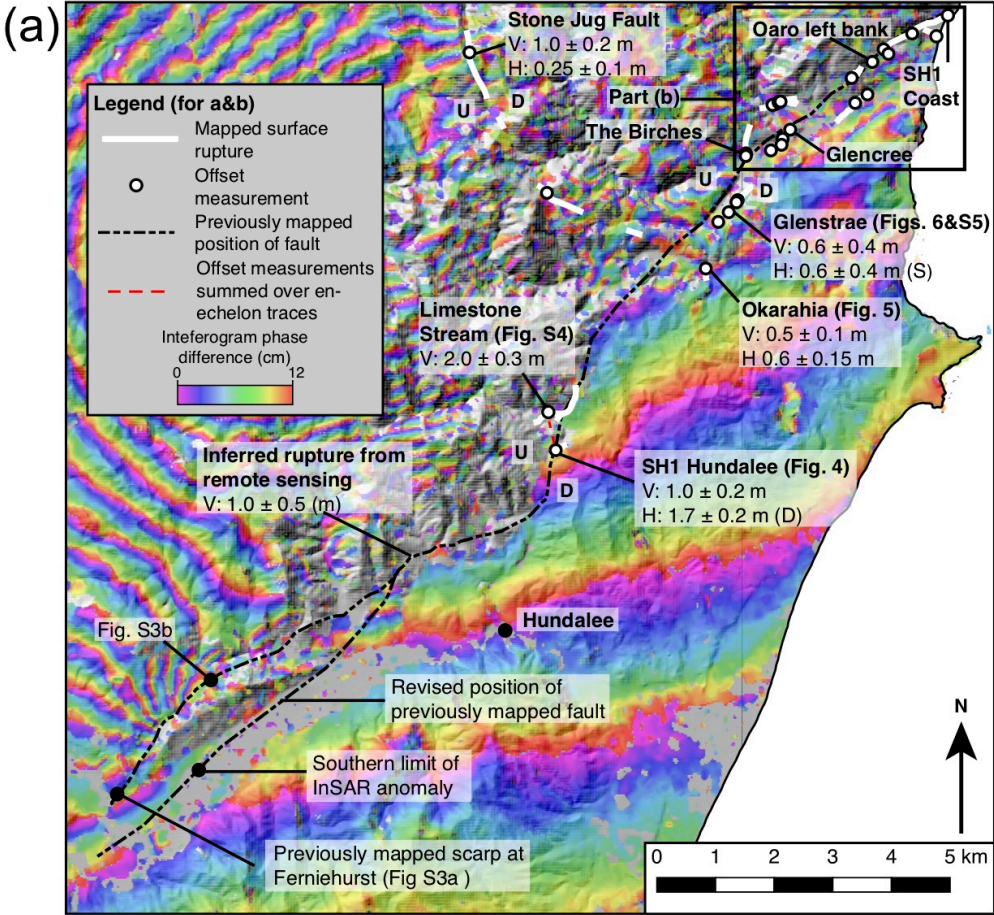
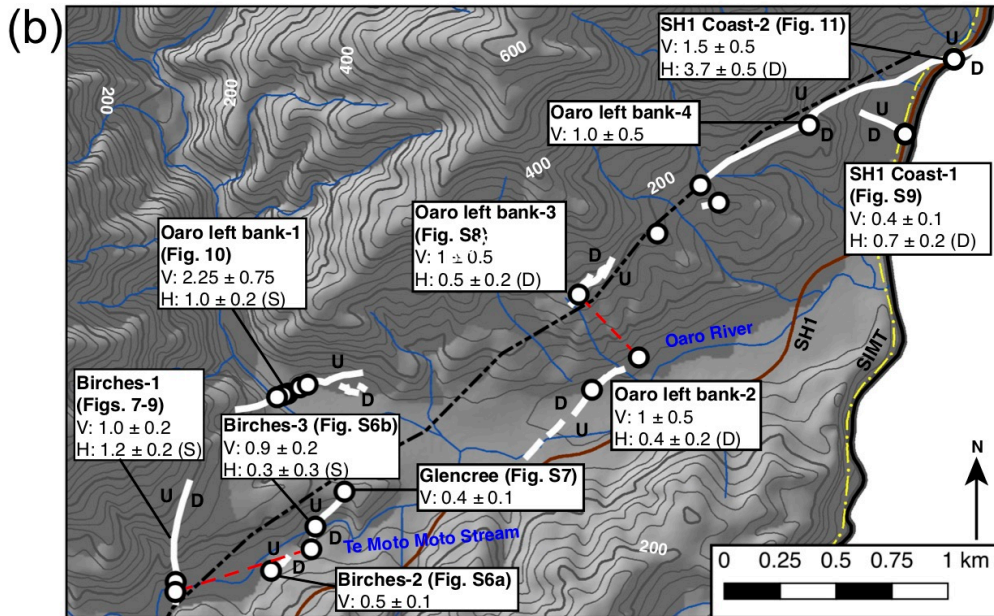
Kaikōura Earthquake surface rupture of the Hundalee Fault is comprised of a series of complex and discontinuous (< 1 km) traces. These are summarized by the surface rupture maps in Fig. 3, and which in Fig. 3a are underlain by InSAR data (Hamling et al., 2017). This revealed a well-defined line of differential ground shift that coincides closely with the previously mapped fault. In the following section, we describe each of the key sites along the Hundalee Fault, starting in the southwest and moving towards the northeast.

726 Figure 3: Surface ruptures along the Hundalee Fault that were formed by the 2016 Kaikōura

interferogram previously documented in Hamling et al., (2017). Extent of area shown in Fig. 2. The previously mapped position of the fault is derived from the QMAP dataset (Rattenbury et al., 2006) and the revised section of the fault is as shown in Fig. 2. These are used in the Hundalee Fault slip distribution plots (Fig. 12). (b) Map demonstrating the highly segmented and non-planar surface ruptures at the northeastern end of the Hundalee Fault. Note the differing sense of strike-slip and dip-slip displacement. In both figure parts, dashed lines indicate transects across which the offset measurements of en-echelon traces have been summed in Fig. 12c. The full range of offset measurements are given for each locality, for individual offset measurements see Table 1. V, vertical offset; H, horizontal offset; (S) and (D) = sinistral and dextral shear sense, U and D = upthrown and downthrown sides of the fault respectively; SH1, State Highway 1; SIMT: South Island Main Trunk Railway. Hillshade for both parts is derived from the Land Information New Zealand (LINZ) 8 m New Zealand Digital Elevation Model illuminated from the northwest. Topographic contours in (b) are at 20 m intervals (thicker lines, 100 m).

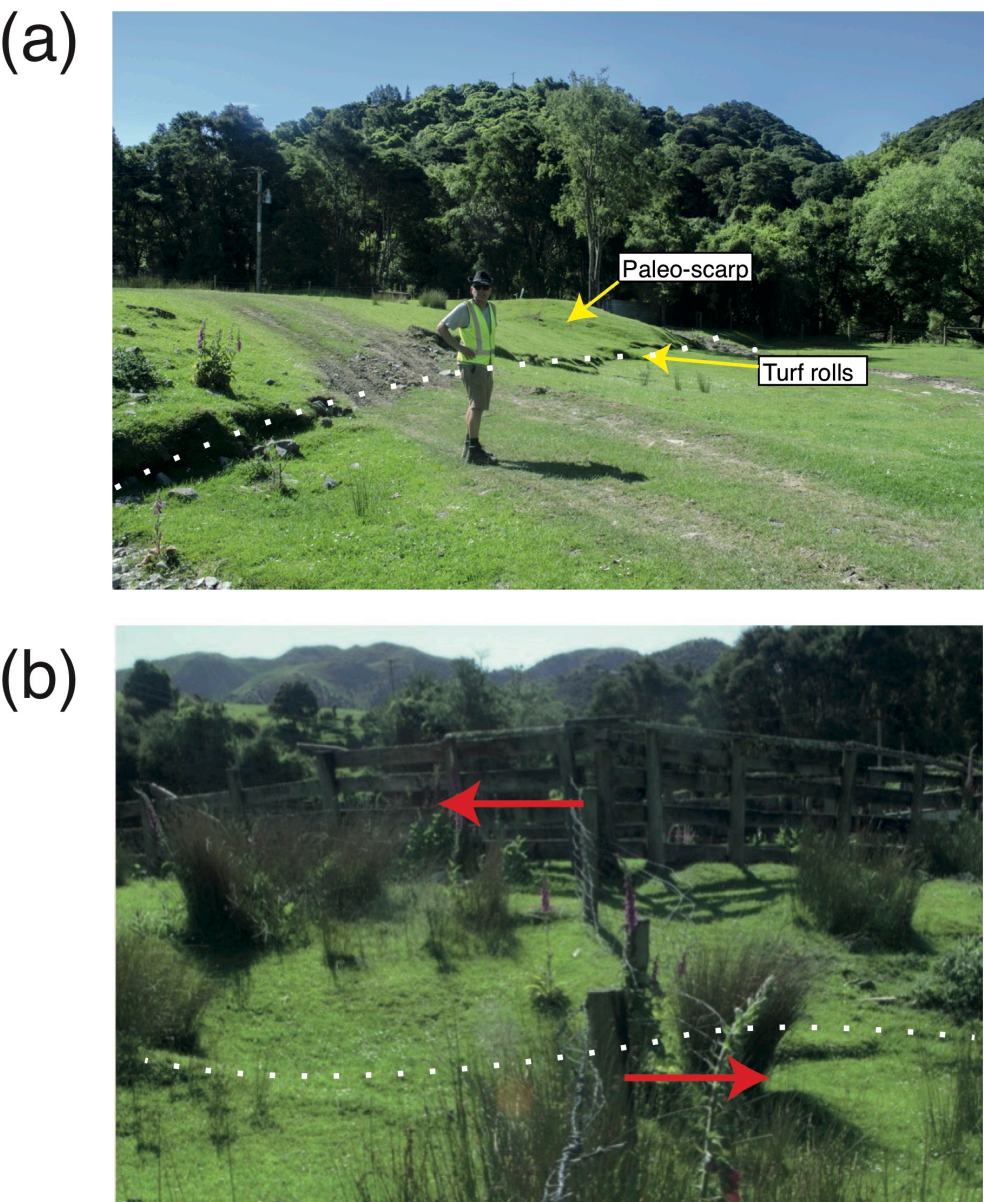
Surface rupture was identified on a south bank terrace of Okarahia Stream about 3.8 km to the northeast of the SH1 Hundalee locality (Fig. 3a). The 190-m long north-trending trace exhibits 0.5 ± 0.1 m of uplift to the west (Fig. 5a), in which slabs of soil and roots were bent and buckled to form ‘turf rolls’ (e.g. Beanland et al., 1989; Little et al., 2018). Fences that cross the scarp at a high angle indicate 0.6 ± 0.15 m of sinistral offset (Fig. 5b, Table 1). There is a topographic step at the same

754
755 Figure 5: Surface ruptures at the Okarahia locality (Fig. 3a). (a) Dotted white line identifies 2016
756 surface rupture, characterized by a 0.5 ± 0.1 m high scarp with prominent turf rolls, taken 23
757 November 2016 looking west. A suspected pre-existing fault scarp at this location is evident in the
758 background. (b) Sinistral-reverse offset (arrows) of 0.6 ± 0.15 m of a fence that crosses the scarp
759 (dotted white line) at a high angle and results in dilation of the fence. Photo taken looking northwest.
760

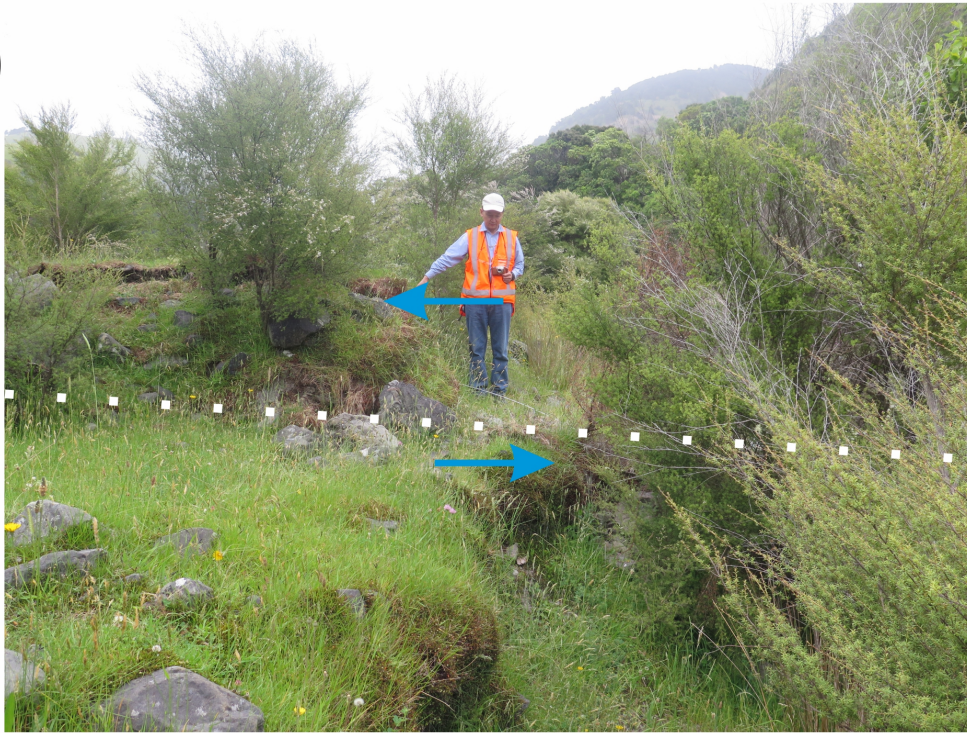
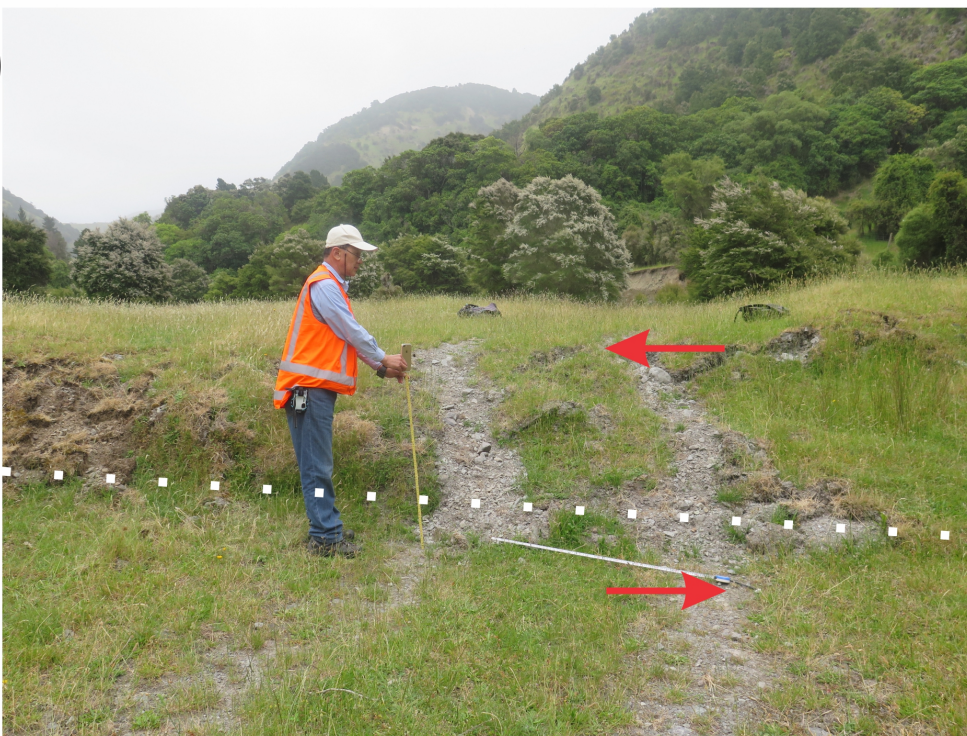
786 Figure 8: (a) View west towards the Birches-1 fault trace across low-level terrace on the south bank of
 787 Te Moto Moto Stream (Fig. 3b), 20 December 2016. Minimal soil development suggests the terrace
 788 surface is at most a few hundred years old. (a) the steep, vegetated, bank (white dotted line) down to
 789 the active stream channel (out of sight to right) has a sinistral offset of 1.1 ± 0.2 m across the fault
 790 (arrows), and the vertical component is also 1.1 ± 0.2 m. (b) The ruts of a vehicle track (arrows

792 marking right-hand rut) 30 m south of the photo (a) scene clearly illustrates the oblique sinistral and
793 up-to-west shift.
794

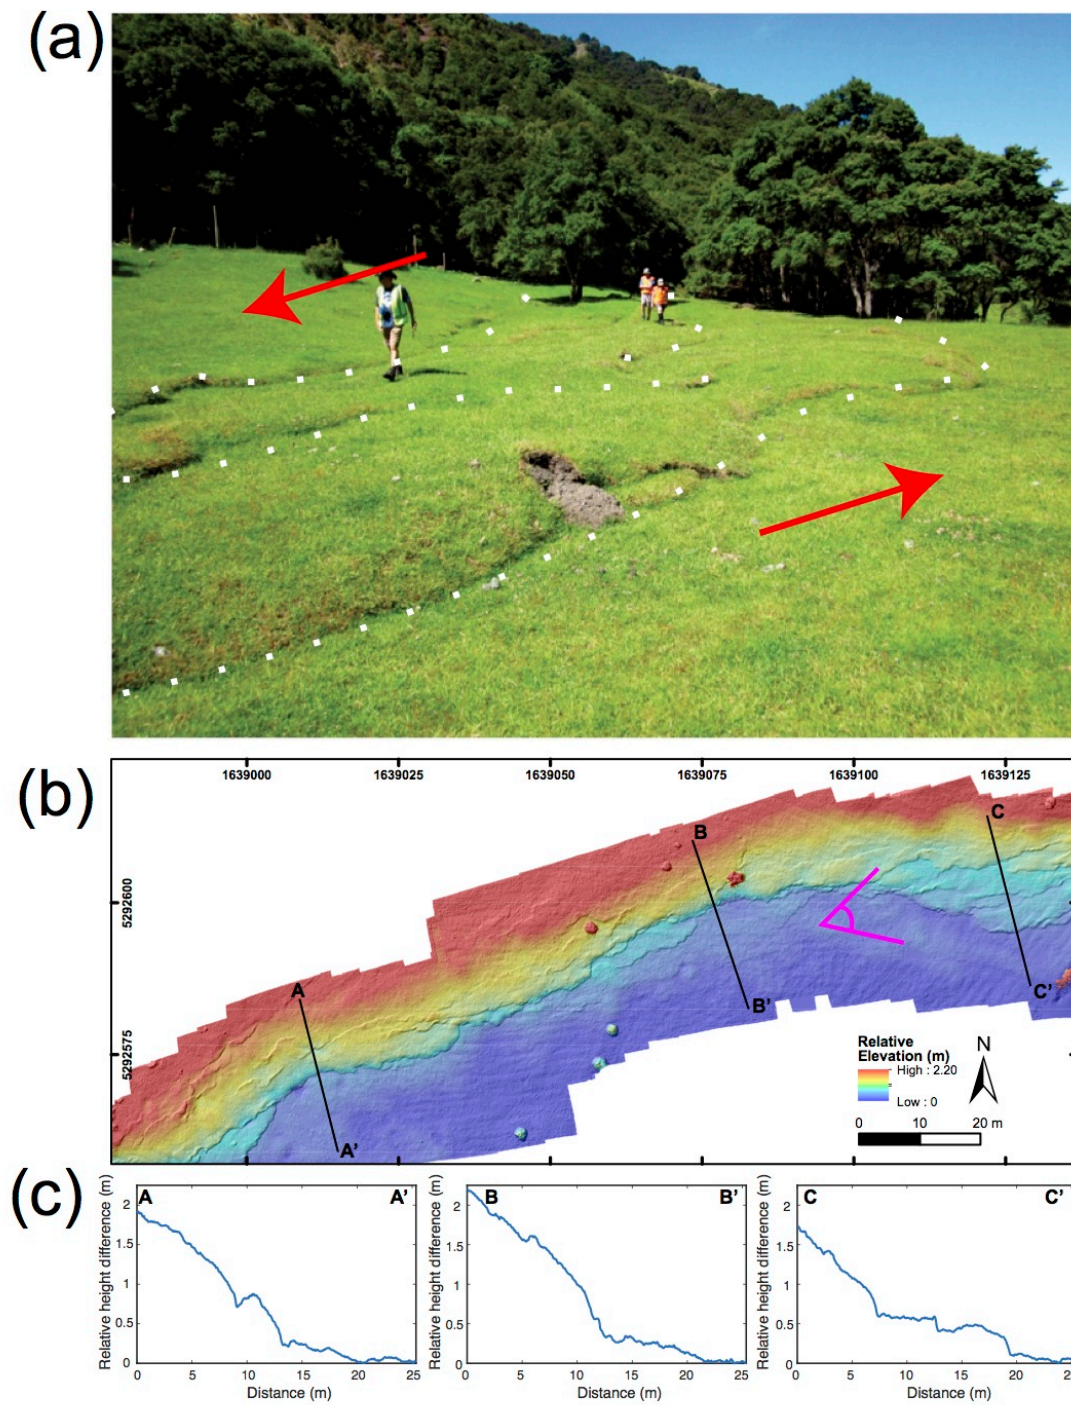
Figure 10

Figure 10: (a) View east-northeast along the Oaro Left Bank-1 fault scarp, ~200 m northeast of the Oaro River channel, showing multiple distributed rupture traces (dotted white lines), taken 22 November 2016. Up-to-the-northwest throw is accompanied by a subordinate sinistral component, identified from a fence-line offset (not shown, see Fig. S1, available in the electronic supplement to this article). Although ~10 m above river level, the flipped turf in the foreground reveals a very

immature soil developed on angular greywacke fine gravel, quite unlike the sub-rounded greywacke pebble bedload of the Oaro River. This terrace is interpreted to be a landslide dam-break aggradation fan, no more than a few hundred years old. (b) Digital elevation model (DEM) of surface ruptures at the Oaro Left Bank-1 locality, constructed from UAV derived photogrammetry model. The two lines with an angle symbol in between, indicates part (a) field of view. Map projection is NZTM/NZGD2000 Datum. (c) Three profiles through the DEM, with letters corresponding to transects indicated in part (b). These illustrate the distributed ground deformation and warping across at >20 m wide zone. Relative height differences should be regarded as a minimum as profiles are too narrow to cover the entire width of the deformation zone.

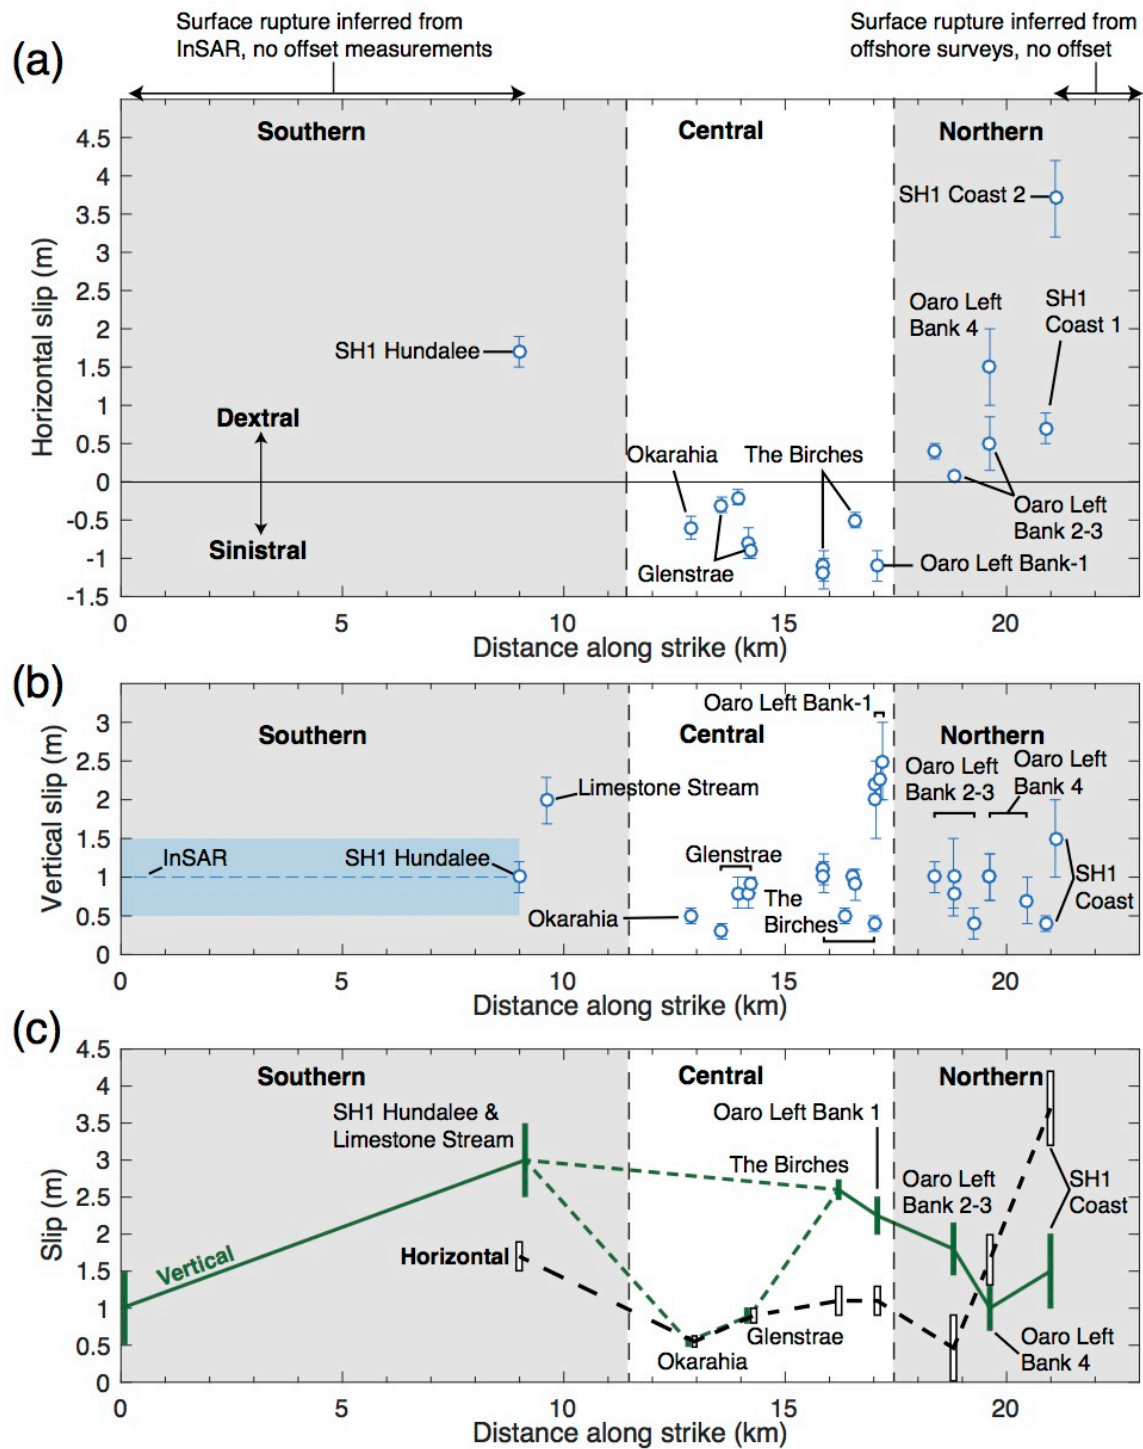
Figure 12

To provide a better understanding of Kaikōura Earthquake rupture of the Hundalee Fault, we compared all offset measurements (Table 1) to their position along strike of the fault, as mapped from bedrock relationships (Figs. 12a-b). Measurements from locations that are off the line of the mapped bedrock position of the fault (e.g. Okarahia) are projected at approximate right angles onto the fault alignment. To provide clarity, a single representative measurement for each locality is shown in Fig. 12c. Where surface ruptures have an *en-echelon* arrangement, we have also summed the offset measurements in Fig. 12c from individual strands (as shown in Fig. 3). Note, we have not aggregated the SH1 Coast offsets, because the two traces have strike approximately perpendicular to one another (Fig. 3b). Measurements derived from InSAR (Hamling et al., 2017) along the southern section of the Hundalee Fault are also included.

Fig. 12 indicates the total length of surface rupture quantified by field observations is ~12 km. However, when we also account for the rupture inferred from InSAR observations (an additional 9 km, Fig. 3a) and offshore from marine surveys (an additional 2 km; Stirling et al., 2017), the total length of Kaikōura Earthquake rupture along the Hundalee Fault is ~23 km.

By summing offsets across *en-echelon* traces, the highest vertical displacement is observed along the central part of the Hundalee Fault where >2 m of offset is noted. In this context, the <1 m vertical offset at the Okarahia and Glenstrae localities is anomalously low, which suggests that deformation may be distributed across additional traces at these localities that we could not identify (as represented by the dashed lines for vertical slip in Fig. 12c). Horizontal displacements show more scatter, with the maximum displacement recorded at the SH1 Coast-2 locality (Fig. 12c). However, no horizontal offset measurements could be made by offshore surveys, so it is unclear whether this locality represents the maximum horizontal co-seismic displacement along the Hundalee Fault, or if it increases offshore to the northeast. We also recognize that some of our measurements are within a

Figure 12: Slip distribution along the Hundalee Fault for (a) horizontal and (b) vertical offset using measurements listed in Table 1. Offset measurements are plotted against the previous mapped trace of the fault (Fig. 3; Warren, 1995; Rattenbury et al., 2006), and are projected onto it if necessary. InSAR is used to estimate vertical displacement along the fault's southern section in part (b), with the

uncertainties represented by the shaded region (Hamling et al., 2017). In (c), offset measurements are aggregated over *en-echelon* traces (SH1 Hundalee and Limestone Stream; The Birches 1 to 3; Oaro Left Bank 2 and 3), with a single representative measurement shown for all other localities to provide clarity. Dashed line for vertical slip in (c) for the Okarahia and Glenstrae localities highlights the anomalously low slip here recorded here and questions whether slip may have been distributed across another *en-echelon* trace that we did not find. Definition of southern, central, and northern sections illustrated in Fig. 13

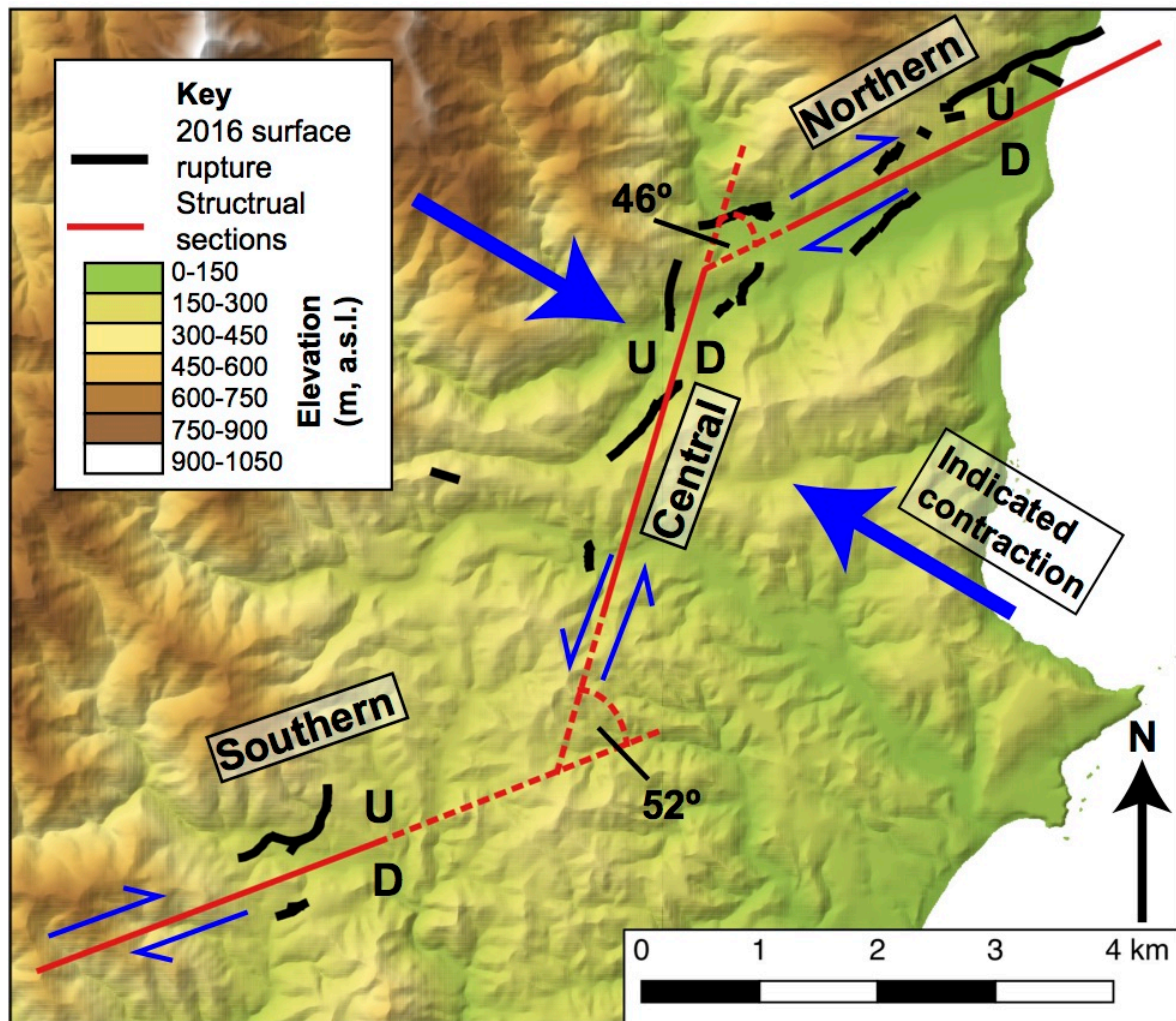
Figure 13

Analyses of rupture trace orientation and our offset measurements allow us to characterize the 2016 slip distribution as three adjoining sections (Figs. 3, 12 and 13). Oblique dextral-reverse slip along northeast trending rupture traces characterizes the south and north sections, while the central section contains north to north-northeast trending ruptures with reverse-sinistral slip (Fig. 13). At a broad scale, the co-existence of dextral-reverse slip along northern and southern strands of the Hundalee Fault and reverse-sinistral slip along central strands may be explained by contraction about a single axis with an orientation of $120 \pm 10^\circ$ (Fig. 13). This implies that the ratio of vertical slip to horizontal slip should be highest in the central section, as is generally observed (Fig. 12c).

Figure 13: Division of the Hundalee Fault into southern and northern sections with east-northeast trending surface ruptures and a central section with north to north-northeast trending surface ruptures. Thick arrows represent contraction direction along an axis of 120° , which is required for the dextral shear sense observed along the northern and southern sections of the Hundalee Fault and sinistral shear sense along the central section. Note the northern-most surface rupture along the central section (Oaro Left Bank-1) is inconsistent with this interpretation. The interior angles between these sections are also shown. Lines are dashed where the end of these sections are projected. U and D = upthrown and downthrown sides of the fault respectively; m, meter; a.s.l., above sea level
